HUNTERS POINT SHIPYARD
PARCEL E EMERGENCY REMOVAL ACTION
LANDFILL GAS CONTROL SYSTEM

TUESDAY 1, OCTOBER 2002
DAILY ENGINEER'S REPORT

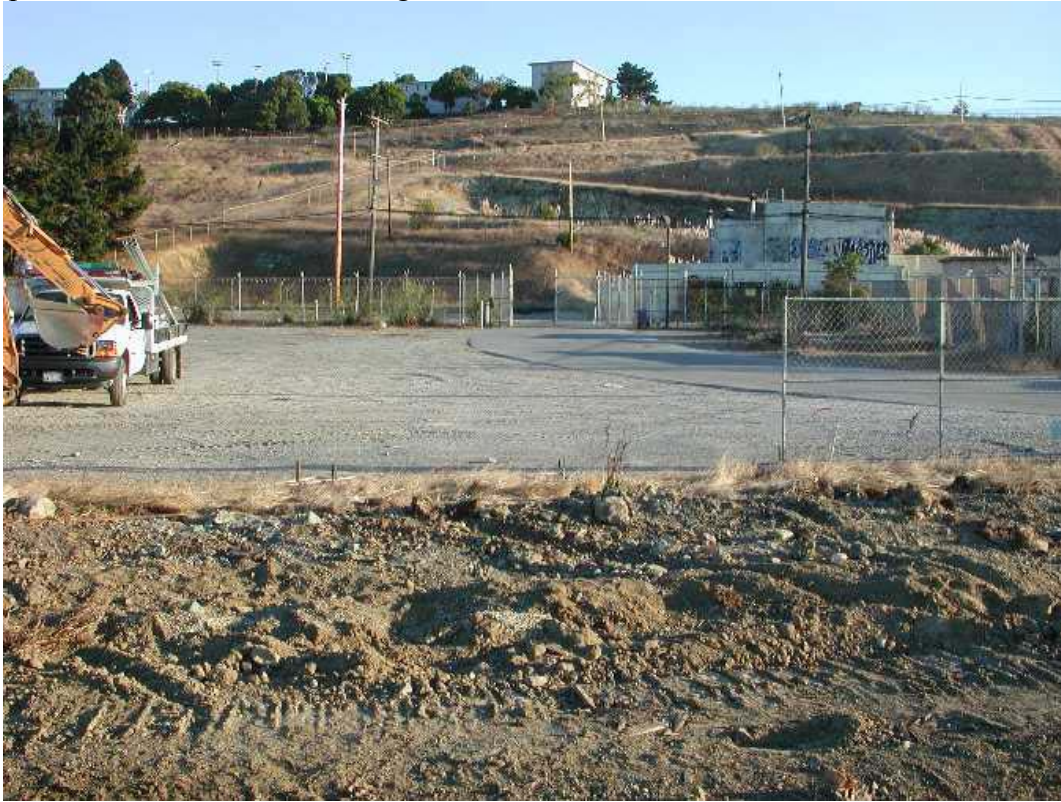
Photograph 1. Section of UCSF fencing removed

- Began removing USCF fencing (~300'). Fencing contractor will be on-site Wednesday to begin installation of replacement fencing. Removing the fencing in sections as the replacement fencing is installed.

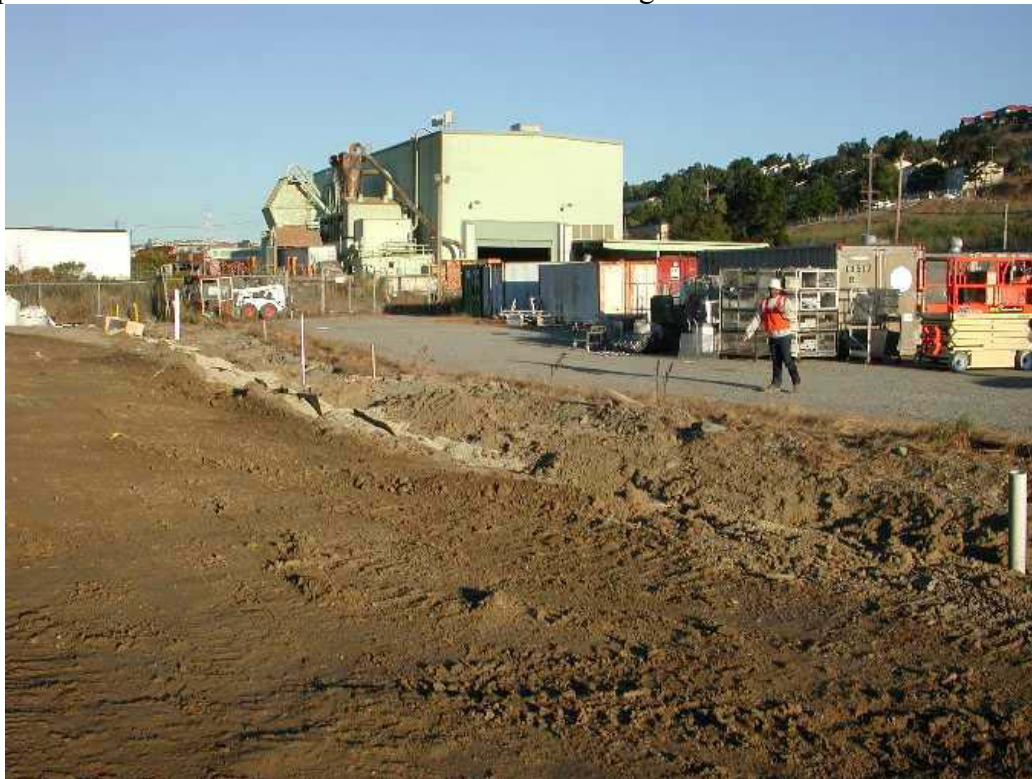
Photograph 2. Continuation of section where UCSF fencing was removed

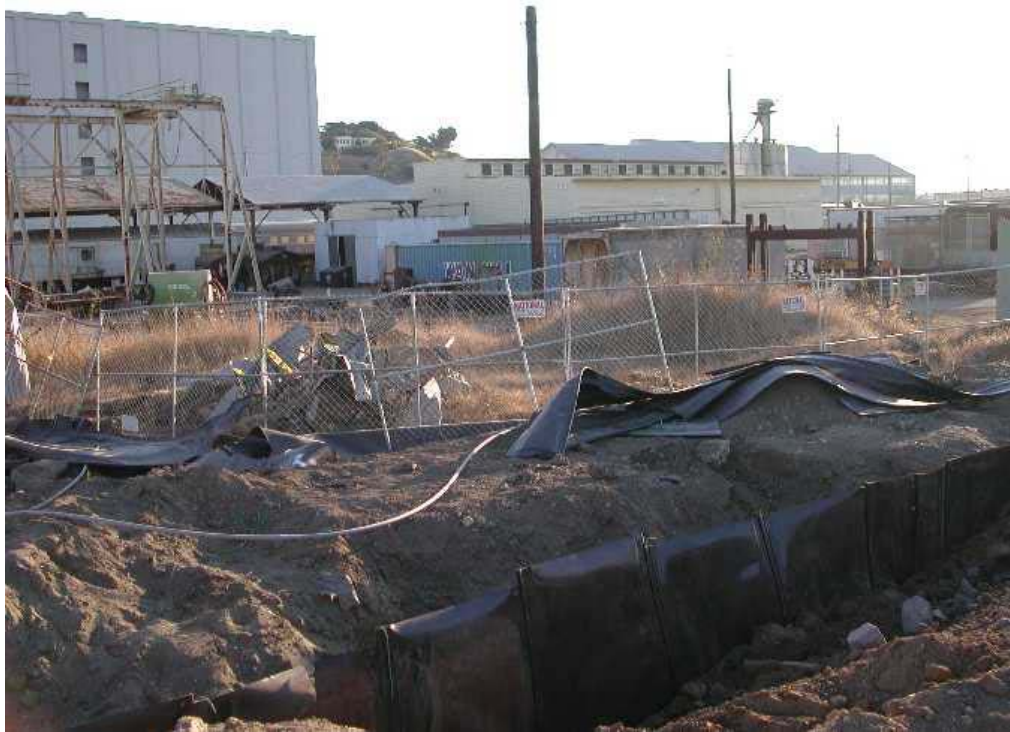
Photograph 3. Gundwall panels successfully joined at this location

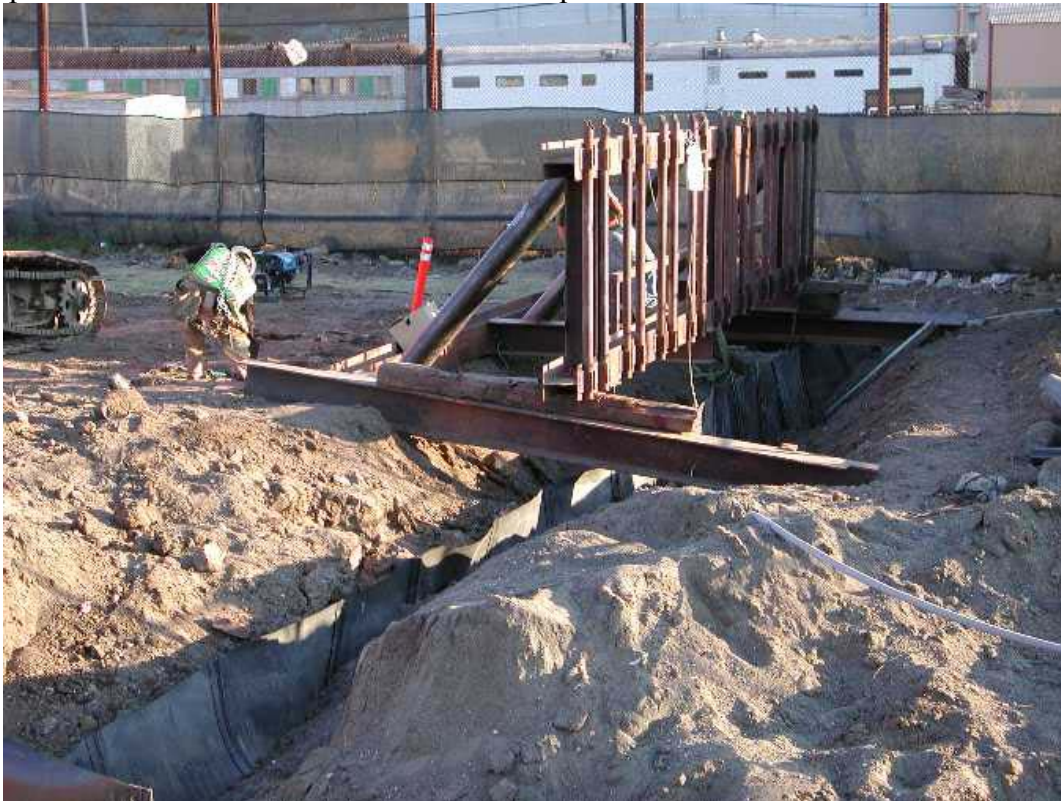
Photograph 4. Last trench section where Gundwall panels had to be reinstalled
